THESIS

DETERMINATION OF THE DUCTILE TO BRITTLE
TRANSITION TEMPERATURE OF
PLATINUM-ALUMINIDE GAS
TURBINE BLADE COATINGS

David J. Vogel

September 1985

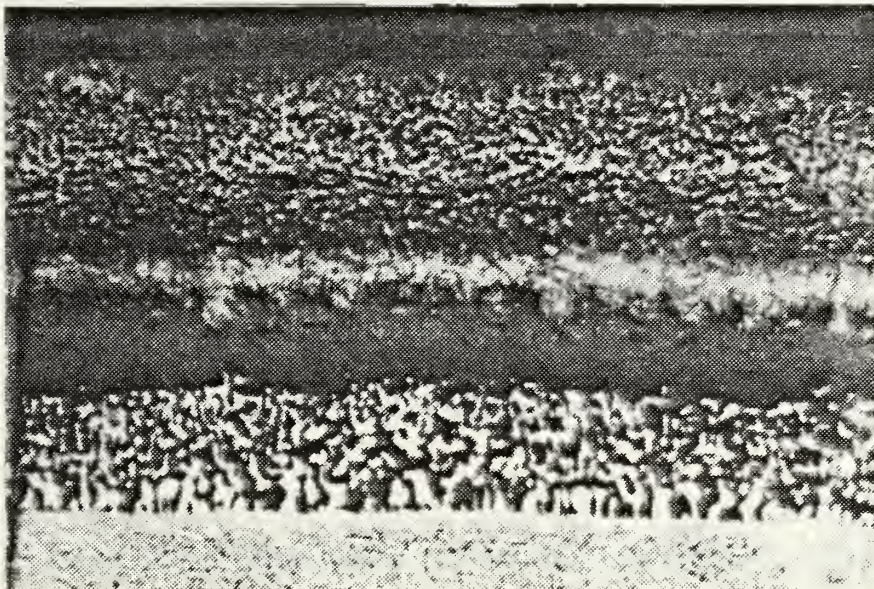
Figure 9. Coating No. 5 - High Pt Diffusion, Outward Ni, Etched (425x)
